Manhole Inspection Summary

Manhole # S35AA1029MH

Insp Date: **1/19/07 9:14 AM**

Location Address: **3415 OAKENSHAW PL**

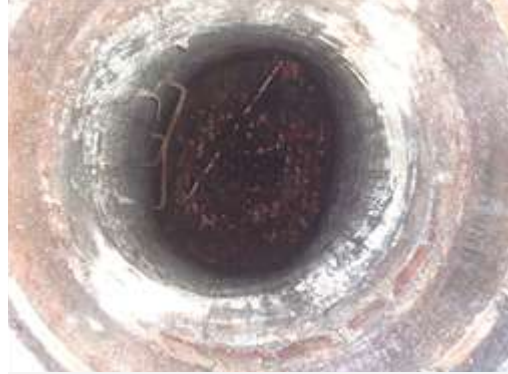
Top View

Corroded and missing steps. Channel debris.

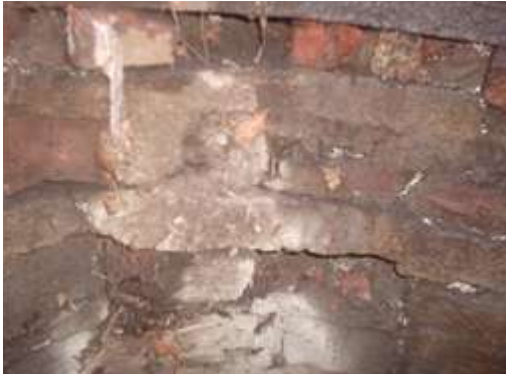
Defect

Adjustment and Corbel deterioration and infiltration.

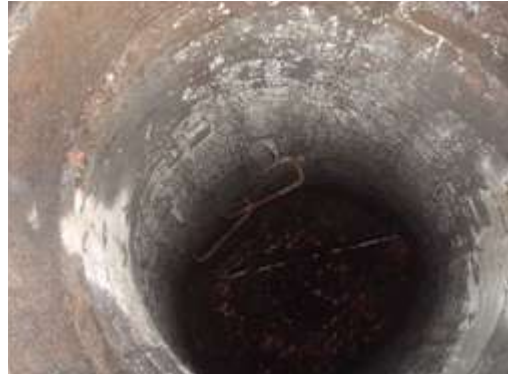
Defect

Frame leaks. Adjustment deterioration and infiltration. Corbel and Barrel infiltration. Corroded and missing steps.

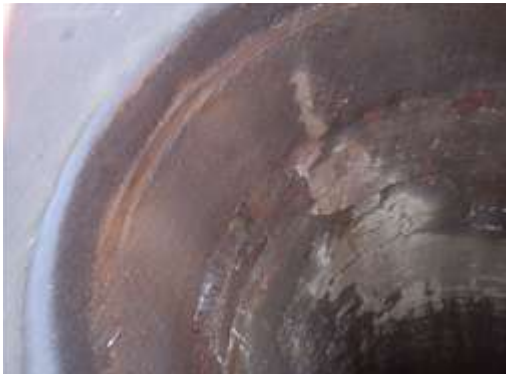
Defect

Frame leaks. Adjustment deterioration and infiltration. Barrel infiltration.

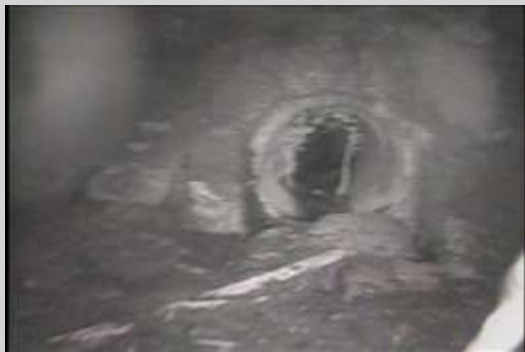
8 in. Circular Gravity Sewer
Pipe Out @ 12 O'Clock

Deposits: ☐ None ☒ **Mud** ☐ Sludge ☒ **Debris** ☐ Grease

Silt Depth: **0.5** (in.) Deposits Extent: **Light**
